## OREGON CORNER RESTORATION FORM

Section County	30 Umatilla	_Township _Date:	1NRange September 3, 2009	32E	
Corner De	esignation:	1N32V1			Condition Report Only Not found
Corner to sections 25 and 36, T1N, R31E, and sections 30 and 31, T1N, R32E, W.M., Umatilla County, Oregon.			x	Remonumented Unrecorded Surveyed in Referenced out

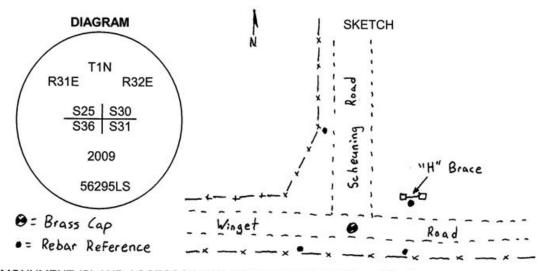
Monument and accessories found. (condition and source) None. The corner falls in the center of an East-West road.

MONUMENT (S) AND ACCESSORIES SET (Procedures and Description)
At the intersection of the centerlines of the East - West road and a road running North I set a 2 1/2" brass cap on a 1 1/2"x30" galvanized iron pipe stamped as shown above. The cap is 8" below the surface of the road.

For references, I set four, 5/8" by 24" iron rebars with 1 1/4" orange plastic caps stamped WTS and 56295LS as described below:
