## **OREGON CORNER RESTORATION FORM**

Section	32	Township	1NRange	31E	
County	Umatilla	_ Date:	October 4, 2001		
					Condition Report Only
Corner Designation: 1N31Z7					Not found
				x	Remonumented
South 1/4 section corner to section 32, T1N, R31E,					Unrecorded
W.M., Umatilla County, Oregon.					Surveyed in
				x	Referenced out

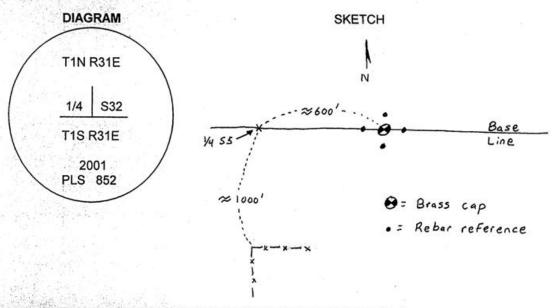
Monument and Accessories found: (condition and source) None. The point falls in a plowed field.

At the proportionate point I set a 7" x 1 1/2" G.I.P. with a 2 1/2" Brass cap stamped as shown in in the diagram above 26" below the surface. The G.I.P. was cemented to a 12" x 5/8" iron rebar that was driven into the bedrock.
