OREGON CORNER RESTORATION FORM

Section 20 Township Range 1N 32E County Umatilla Date: August 24, 2009 Corner Designation: 1N32P9 Condition Report Only Not found Quarter corner common to sections 20 and 21, Remonumented T1N, R32E, W.M., Umatilla County, Oregon. Unrecorded Surveyed in Referenced out

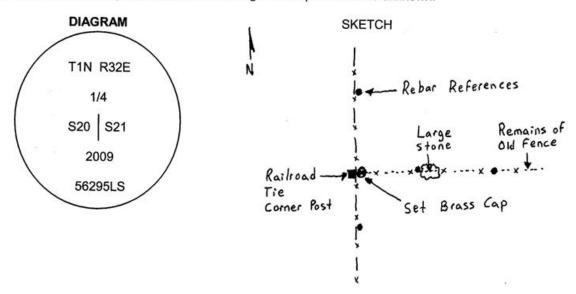
I found the original basalt stone, 20x15x7 ins. lying flat on it's side on the west side of a railroad tie fence corner post with fences running north, south, and east. There was a broken plow shear driven vertically along side the stone. The origin of the plow shear is unknown.

MONUMENT (S) AND ACCESSORIES SET (Procedures and Description)
At the position of the plow shear I set a 1 1/2" x 30" galvanized iron pipe with a 2 1/2" brass cap stamped as shown in the diagram above. I buried the stone and the plow shear along side.
