OREGON CORNER RESTORATION FORM

Section County	4 Umatilla	Township _ Date:	1SRange December 11, 2015	32E_	
Corner Des	signation:	1S32C9			Condition Report Only Not found
Quarter corner to sections 4 and 5, T1S, R32E, W.M. Umatilla County, Oregon.				X	_Remonumented Unrecorded _Surveyed in _Referenced out

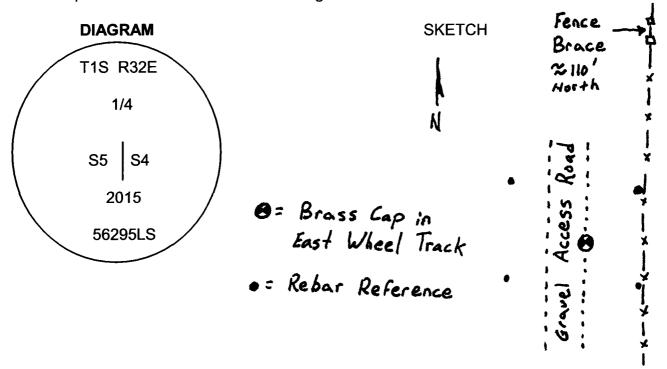
Monument and Accessories found: (condition and source) None. This position falls in the east track of a gravel field road.

At the position determined from Staebler's survey, I set a 2 1/4"brass cap on a 1 1/2" x 30" galvanized iron pipe stamped as shown in the diagram above 6 inches below the surface of the road.
