OREGON CORNER RESTORATION FORM

Section 10 Township 2 N Range 33E

County Umatilla Date Jan. 1994

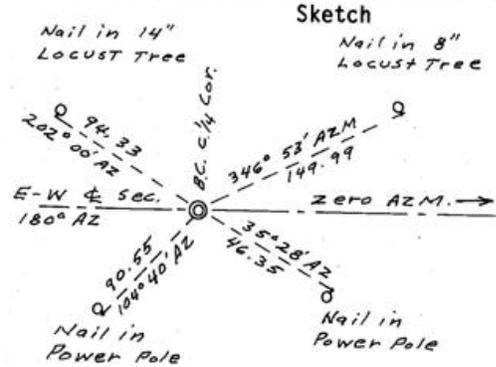
Monument Detail

Found railroad spike that has been used in the past and was referenced with a hub and tack 55.15 ft. to south and a P-K nail on line approx. another 200' + south. These references were placed before construction started of the new road surface and grade.

Set 2 1/2" brass cap on 1" x 30" G.I.P. 6" below paved surface in a C.I. monument box with a lid.

New Accessories 1. Set alum. nail in middle of bearing object sign on N. E. face of power pole S.E. 46.35' from the corner.

2. Set alum. nail in middle of bearing object sign on E. face of power pole S. W. 90.55 ft. from the corner.

3. Set alum. nail in middle of bearing object sign on S. face of a 14" diameter locust tree N.W. 94.33 ft. from the corner.

4. Set alum. nail in middle of a bearing object sign on S. face of a 8" diameter locust tree N. E. 149.99 ft. from the corner.
