OREGON CORNER RESTORATION FORM

Section 30 Township 3N Range 28E
 County Umatilla Date: 06-14-02

Corner Designation: 3N28V1

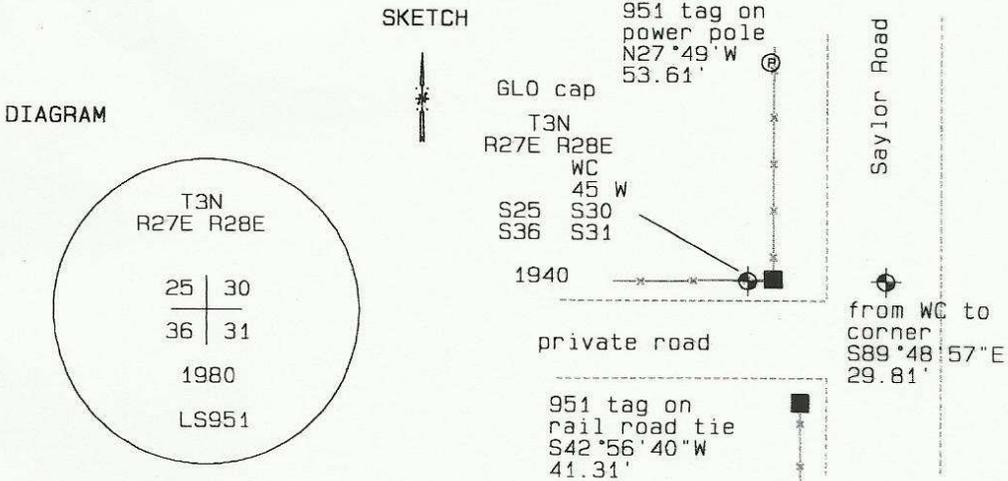
Found a brass capped monument stamped as shown on the drawing in good condition 6" below the surface of the road.
