OREGON CORNER RESTORATION FORM

Section County	32 Umatilla	_Township _Date:	3N Range September 14, 2016	<u>30E</u>	
Corner Des	signation:	3N30X9			Condition Report Only Not found
Quarter corner common to sections 32 and 33, T3N, R30E, W.M., Umatilla County, Oregon.				x	_Remonumented Unrecorded
		·	_	X	_Surveyed in

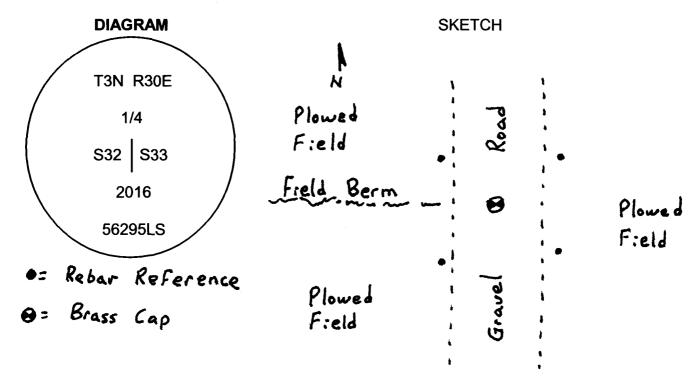
This point falls in a county road running north and south with a plow berm running west.

MONUMENT (S) AND ACCESSORIES SET (Procedures and Description)
I set a 1 1/2" x 30" galvanized iron pipe with a 2 1/2" brass cap stamped as shown in the diagram above at the intersection of the road centerline and the plow berm. The cap is 6" below the surface of the road.
