OREGON CORNER RESTORATION FORM

Date: 3/18/2011

Quarter corner common to Sections 20, 29, T3NR33E.

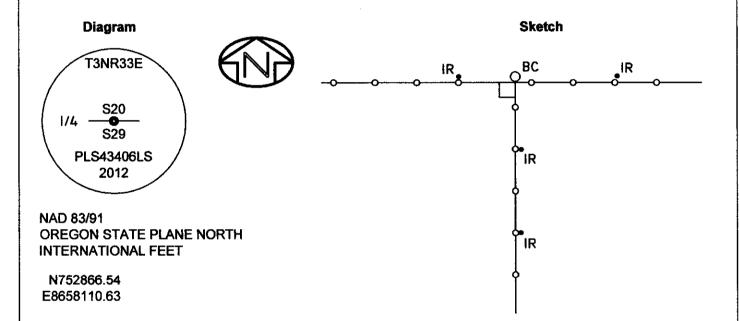
Monuments and Accessories Found: (Condition and Source):

In 1998 Krumbein set a 1" iron pipe with 2 1/2" brass cap in Survey 11-85-C. This survey was not filed until after several subsequent surveys were filed, including the corners set in our survey. This creates the distinct probability that there are double corners in the survey affected by 11-85-C.

A 1 1/8" x 30" galvanized iron pipe with 2 1/2" brass cap, stamped as shown above, 2" below the surface.
