OREGON CORNER RESTORATION FORM

Section 3 Township 3N Range 27E
County Umatilla Date: 06-14-02

Corner Designation: 3N27A15

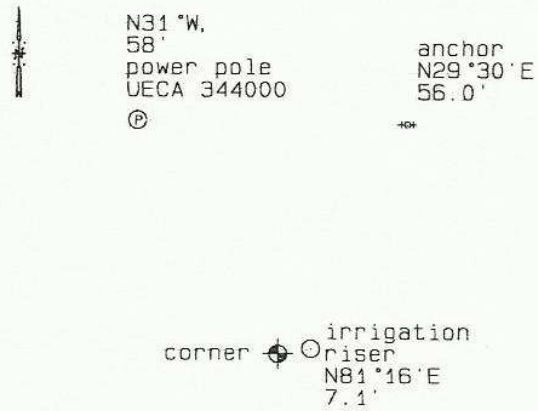
SKETCH

Found standard GLO brass cap on 1" iron pipe in intersection of Col. Jordan and County Line Roads. Corner is 3" below surface and has been bent to south.
