CORNER RESTORATION FORM

Township 4N Range 29E Section 29, 30 County UMATILLA

State OREGON Date 3/30/2023 Number T-5

Corner Designation : 1/4 CORNER: 29, 30

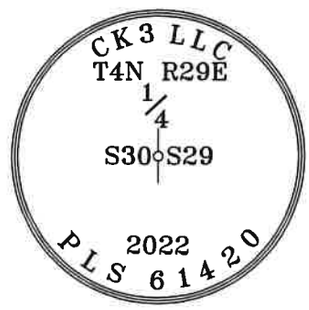
MONUMENT DETAIL

FOUND A 2-3/8" BRASS CAP 4" BELOW GRADE IN ROAD, STAMPING NOT LEGIBLE, RESTAMPED AS SHOWN, COUNTY SURVEY NO. S-158-C

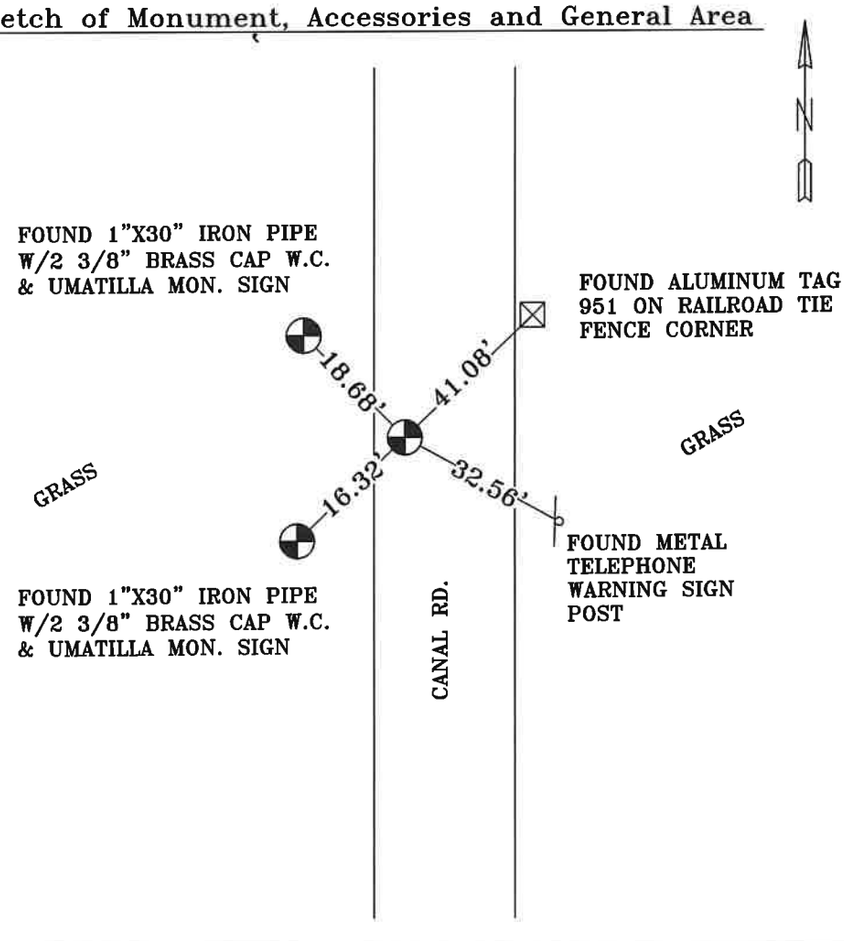
Sketch of Monument, Accessories and General Area

FOUND A METAL TELEPHONE WARNING SIGN POST S 61°14' E 32.56', CORNER FORM NO. T5-95-060-B

FOUND A 1"X30" IRON PIPE W/ 2-3/8" BRASS CAP W.C. & UMATILLA MON. SIGN N 44°56' W 18.68', CORNER FORM NO. T5-95-060-B

FOUND A 1"X30" IRON PIPE W/ 2-3/8" BRASS CAP W.C. & UMATILLA MON. SIGN S 46°03' W 16.32', CORNER FORM NO. T5-95-060-B

FOUND A ALUMINUM TAG 951 ON RAILROAD TIE POST N 46°31' E 41.08', CORNER FORM NO. T5-95-060-B
