OREGON CORNER RESTORATION FORM

Section 24, 25 Township 5N Range 30E
County Umatilla Date: 05-08-2006

Corner Designation: 5N30E R23

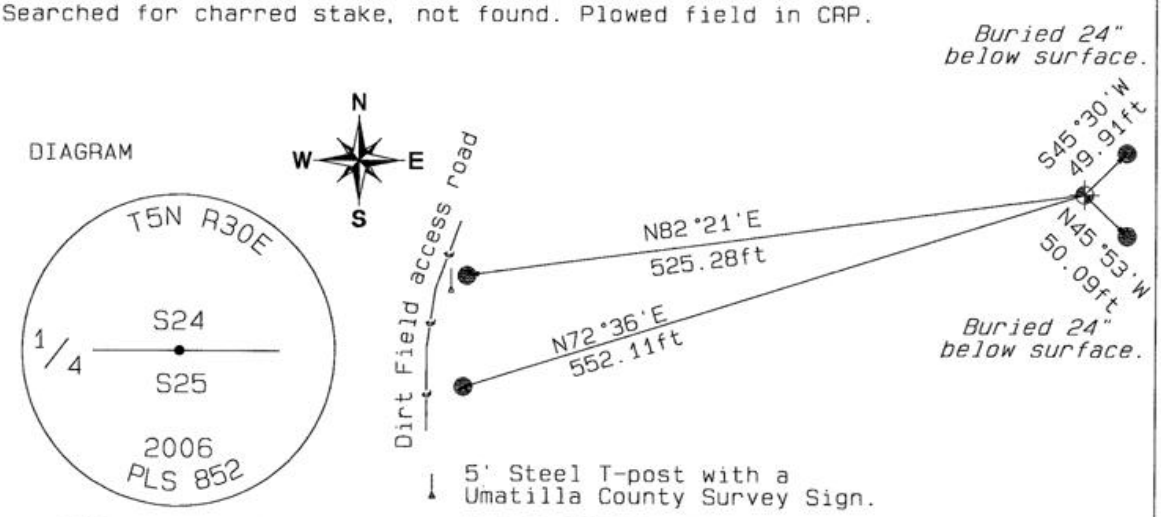
DIAGRAM

Monument and Accessories Found: (condition and source)
Searched for charred stake, not found. Plowed field in CRP.

Set a 2-3/8"dia.Brass Capped monument (stamped as shown) on a 1-1/4"ID x 30"long galvanized pipe 24" below the ground surface. Set a 5' steel T-Post with a Umatilla County Survey Marker sign facing South 525 feet Southwest of the buried corner. amd West of the NW RM.

Set four (5/8" dia x 30" long Iron rebar with a 1.3" dia. Red plastic cap) to the bearings and distances from monument shown above in the sketch.
