OREGON CORNER RESTORATION FORM

Section 30 Township 5N Range 30E
County Umatilla Date: 05-08-2006

Corner Designation: 5N30E T25

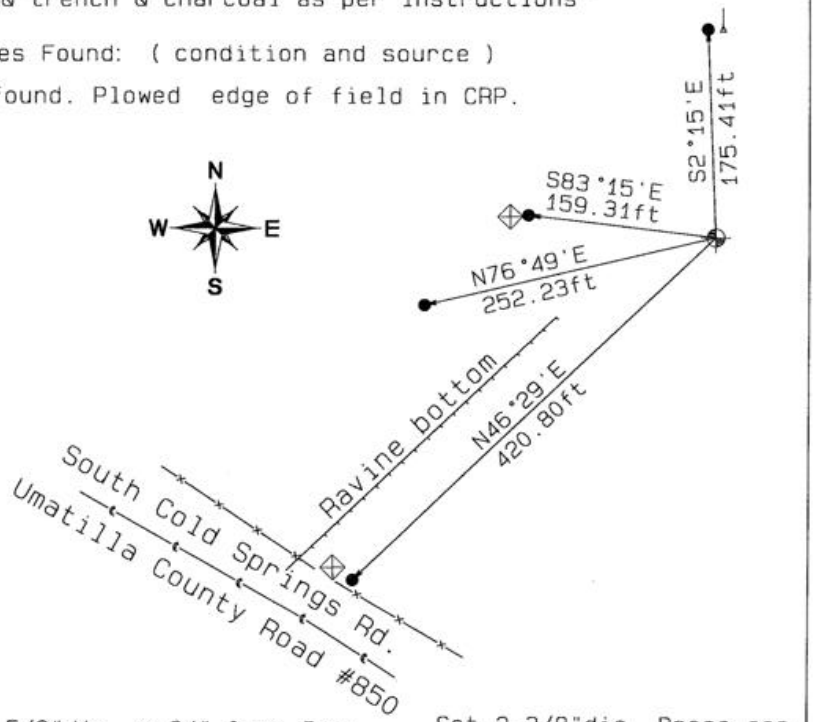
DIAGRAM

Searched for post. Not found. Plowed edge of field in CRP.

Wood fence post

Wire Fence line

5/8"dia. x 24" long Iron Rebar with a 1.3"dia. Red plastic cap.

Ravine bottom

Set 2-3/8"dia. Brass cap on a 1-1/2" x 30" long Galvanized pipe monument.

5' Steel T-post.

Set a 2-3/8"dia.Brass Capped monument (stamped as shown) on a 1-1/4"ID x 30"long galvanized pipe 24" below the ground surface. Set a Umatilla County Survey Marker sign on a lone wooden fence post Northwest with a RM. UCSM and Bearing Object sign are facing Southeast.

Set four (5/8" dia x 30" long Iron rebar with a 1.3" dia. Red plastic cap) to the bearings and distances from monument shown above in the sketch.
