OREGON CORNER RESTORATION FORM

Section 26, 35 Township 5N Range 30E
County Umatilla Date: 09-18-2006

Corner Designation: 5N30E V20

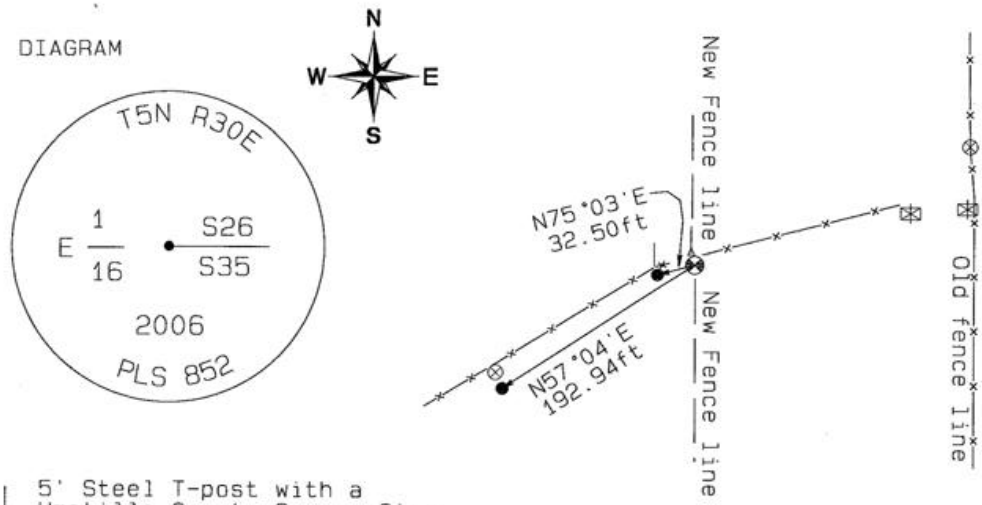
DIAGRAM

Searched for and did not find charred stake. Plowed fields.

5' Steel T-post with a Umatilla County Survey Sign.

5/8"dia. x 30" long Iron Rebar with a 1.3"dia. Red plastic cap.

Set 2"dia. Aluminum cap on a 5/8" x 30" long Iron Rebar.

5' steel T-post

Wood fence post

RR Tie Wood fence post

Set a 2"dia.Aluminum Cap (stamped as shown) on a 5/8"dia. x 30"long Iron Rebar 2" above the ground surface on existing fence line.
Set a 5' steel T-Post with a Umatilla County Survey Marker sign facing South 6 inches South of the corner.

Set two (5/8" dia x 30" long Iron rebar with a 1.3" dia. Red plastic cap) to the bearings and distances from monument shown above in the sketch.
