# OREGON CC NER RESTORATION FORM

Section 31 Township 5N Range 31E
County Umatilla Date: 10-29-2006

Corner Designation: 5N31E X4

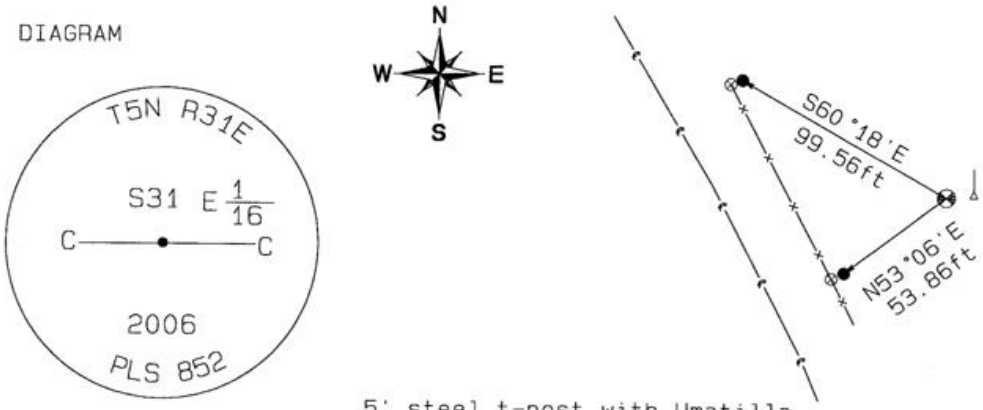
DIAGRAM

No monument found. Found 5" x dia x 5' long steel - hollow axle Northwest of the corner on top of the ground surface - East of a wood fence post.

Set a 2"dia. Aluminum Capped monument (stamped as shown) on a 5/8"OD x 30"long Iron rebar 2" above the ground surface
Set a 5' steel T-post with a Umatilla County Survey Marker sign 12" North of the monument .

Set two (5/8" dia x 30" long Iron rebar with a 1.3" dia. Red plastic cap) to the bearings and distances from monument shown above in the sketch.
