AND 28 HAVE BEEN EXTENSIVELY OBLITERATED SINCE THE 1866 SUBDIVISION SURVEY. SURVEY NO. 88-042-C WAS MADE BY MYSELF IN 1988 REVEALED ORIGINAL DEPUTY SURVEYOR WILLIAM ODELL USED IMPROPER METHODS BY "STUBBING" LINES IN SUBDIVIDING THE TOWNSHIP. "STUBBING" RESULTS IN IRREGULAR LINES BETWEEN CORNERS NOT MEASURED BETWEEN. DURING SURVEY NO. 88-042-C, I RECOVERED ORIGINAL EVIDENCE, (BEARING TREES OR BEARING TREE STUMPS) FOR THE SOUTH AND WEST 1/4 CORNERS OF SECTION 28. DURING SURVEY RESEARCH. A FEW PERTINENT SURVEYS, MADE BY COUNTY SURVEYORS AND RECORDED IN RECORD OF PRIVATE SURVEYS BOOKS 1 AND 2 WERE FOUND AND UTILIZED TO THE EXTENT POSSIBLE, ENTRY OF SURVEYS MADE BY COUNTY SURVEYORS INTO BOOKS 1 AND 2 ENDED AROUND 1940. THERE WERE UNDOUBTEDLY MANY OTHER SURVEYS MADE BY PRIVATE SURVEYORS AND ENGINEERS BETWEEN THE ORIGINAL SURVEYS IN 1866 AND THE BEGINNING OF OREGON'S SURVEY RECORDING ACT IN ABOUT 1950. UNFORTUNATELY, NEARLY ALL OF THE OLD PRIVATE SURVEY RECORDS FOR SURVEYS NOT MADE BY COUNTY SURVEYORS PRIOR TO OREGON'S SURVEY RECORDING ACT ARE LOST. IT'S MY OPINION HOWEVER, AFTER SURVEYING IN UMATILLA COUNTY FOR NEARLY 45 YEARS, THAT MANY FENCES AND OTHER IMPROVEMENTS ARE BASED ON UNRECOR

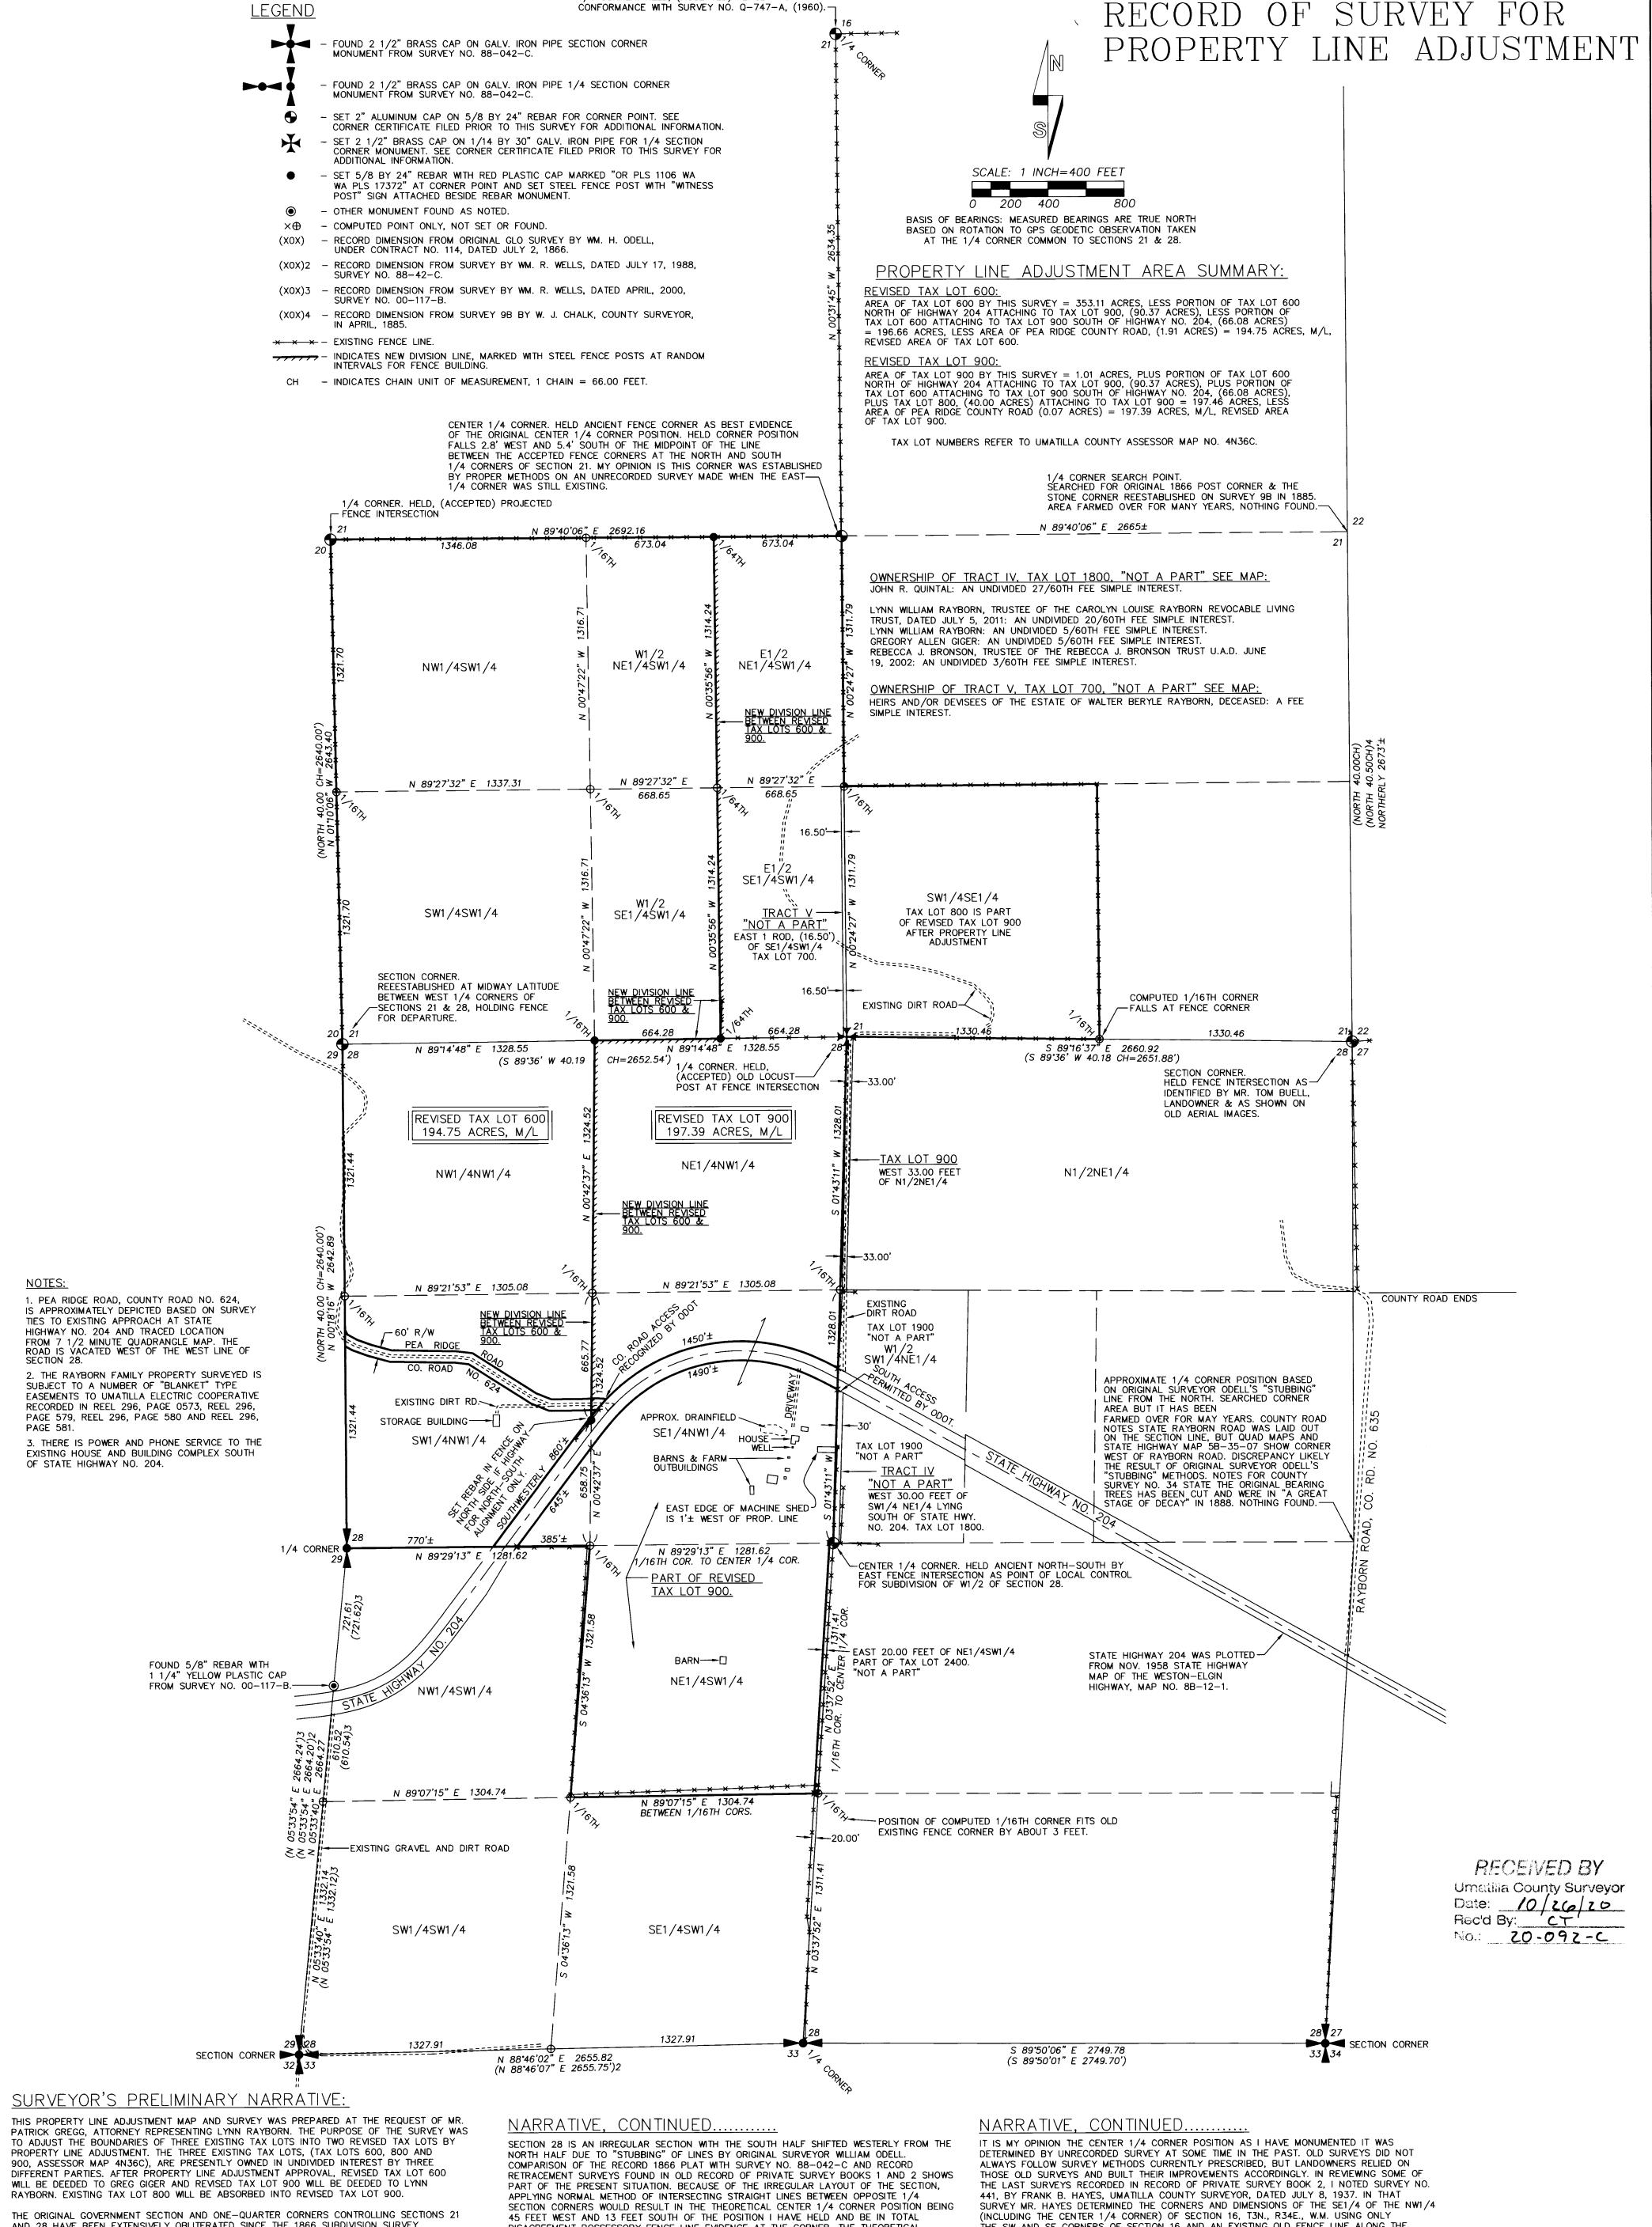
1/4 CORNER. HELD, (ACCEPTED) FENCE INTERSECTION IN

IN SECTION 21, I ACCEPTED AND MONUMENTED ANCIENT FENCE CORNERS FOR THE NORTH, WEST AND SOUTH 1/4 CORNERS AND HELD A FENCE INTERSECTION AS IDENTIFIED BY MR. TOM BUELL FOR THE SOUTHEAST CORNER OF THE SECTION. AT THE SOUTHWEST CORNER OF THE SECTION I REESTABLISHED THE CORNER AT MID-WAY LATITUDE BETWEEN 1/4 SECTION CORNERS NORTH AND SOUTH, HOLDING THE OLD NORTH-SOUTH FENCE LINE FOR DEPARTURE. I ACCEPTED AND MONUMENTED THE ANCIENT FENCE CORNER AT THE CENTER 1/4 CORNER AFTER CONFIRMING IT'S POSITION RELATIVE TO OTHER ACCEPTED GOVERNMENT CORNÉRS ON THE PERIMETER OF THE SECTION. IT'S MY OPINION THE CENTER 1/4 FENCE CORNER POSITION WAS ESTABLISHED BY UNRECORDED SURVEY AFTER THE LAND PATENTS WERE ISSUED FOR THE NORTHWEST AND SOUTHWEST QUARTERS OF SECTION 21 IN THE 1890S. SEE NOTES ON THIS

DISAGREEMENT POSSESSORY FENCE LINE EVIDENCE AT THE CORNER. THE THEORETICAL POSITION WOULD CAUSE 1/4 SECTION LINES TO CUT THROUGH AN EXISTING MACHINE SHED. PLACE FUEL TANKS ON THE WRONG SIDE OF THE LINE AND PLACE THE EXISTING OLD ACCESS LANE ON THE WRONG PROPERTY. THE CENTER 1/4 CORNER OF SECTION 28 IS THE CORNER OF TWO 1875 LAND PATENTS AND IS ON THE WEST LINE OF A THIRD 1875 PATENT.

I HELD THE INTERSECTION OF THE EXISTING NORTH-SOUTH FENCE LINE WITH THE PROJECTED WESTERLY INTERSECTION OF A FENCE LINE EXTENDING EAST AS THE POINT OF LOCAL CONTROL FOR THE CENTER 1/4 CORNER FOR SUBDIVISION OF THE WEST HALF OF SECTION 28, AND MONUMENTED THE CORNER POINT. THIS POSITION HAS BEEN HELD BY ADJOINING OWNERS FOR AT LEAST 60 YEARS, (BASED ON 1956 AERIAL PHOTOGRAPHY). 1958 STATE HIGHWAY MAP 8B-12-1 STATES A "CHARRED STAKE" WAS FOUND FOR THE CENTER 1/4 CORNER. THERE IS NO EXISTING RECORD FOR A "CHARRED STAKE" AT THIS CORNER DESPITE HAVING TIES TO TWO EXISTING ORIGINAL CORNERS COMMON WITH THE STATE HIGHWAY MAP, I AM UNABLE TO DETERMINE A POSITION FOR THE "CHARRED STAKE", DUE TO UNRESOLVED MATHEMATICAL ERRORS ON THE STATE HIGHWAY MAP. HOWEVER, THE STATE MAP CLEARLY SHOWS THE "CHARRED STAKE" POSITION AT THE SOUTHWEST CORNER OF THE DEEDED 30 FOOT STRIP OF LAND CONTAINING THE EXISTING ACCESS LANE, WHICH CORRESPONDS WITH MY MONUMENTED POSITION FOR THE CENTER 1/4 CORNER.

THE SW AND SE CORNERS OF SECTION 16 AND AN EXISTING OLD FENCE LINE ALONG THE SOUTH LINE OF THE N1/2 OF THE N1/2 OF THE SECTION. WOOD STAKES WERE SET AT THE CORNERS OF THE SE1/4 OF THE NW1/4 AND ALONG THE LINES AT 200 FOOT INTERVALS, (PRESUMABILY FOR FENCING). THIS CONFIRMS MY REASONING THAT OLD SURVEYS DID NOT ALWAYS FOLLOW PRESCRIBED METHODS, EVEN WHEN PERFORMED BY THE COUNTY SURVEYOR, YET PROPERTY OWNERS HAVE RELIED ON THE OLD SURVEYS WHEN CONSTRUCTING IMPROVEMENTS.
