RECEIVED BY
Umatilla County Surveyor
Date: 11 22 23
Rec'd By: CT
No.: 23-104-C

NARRATIVE

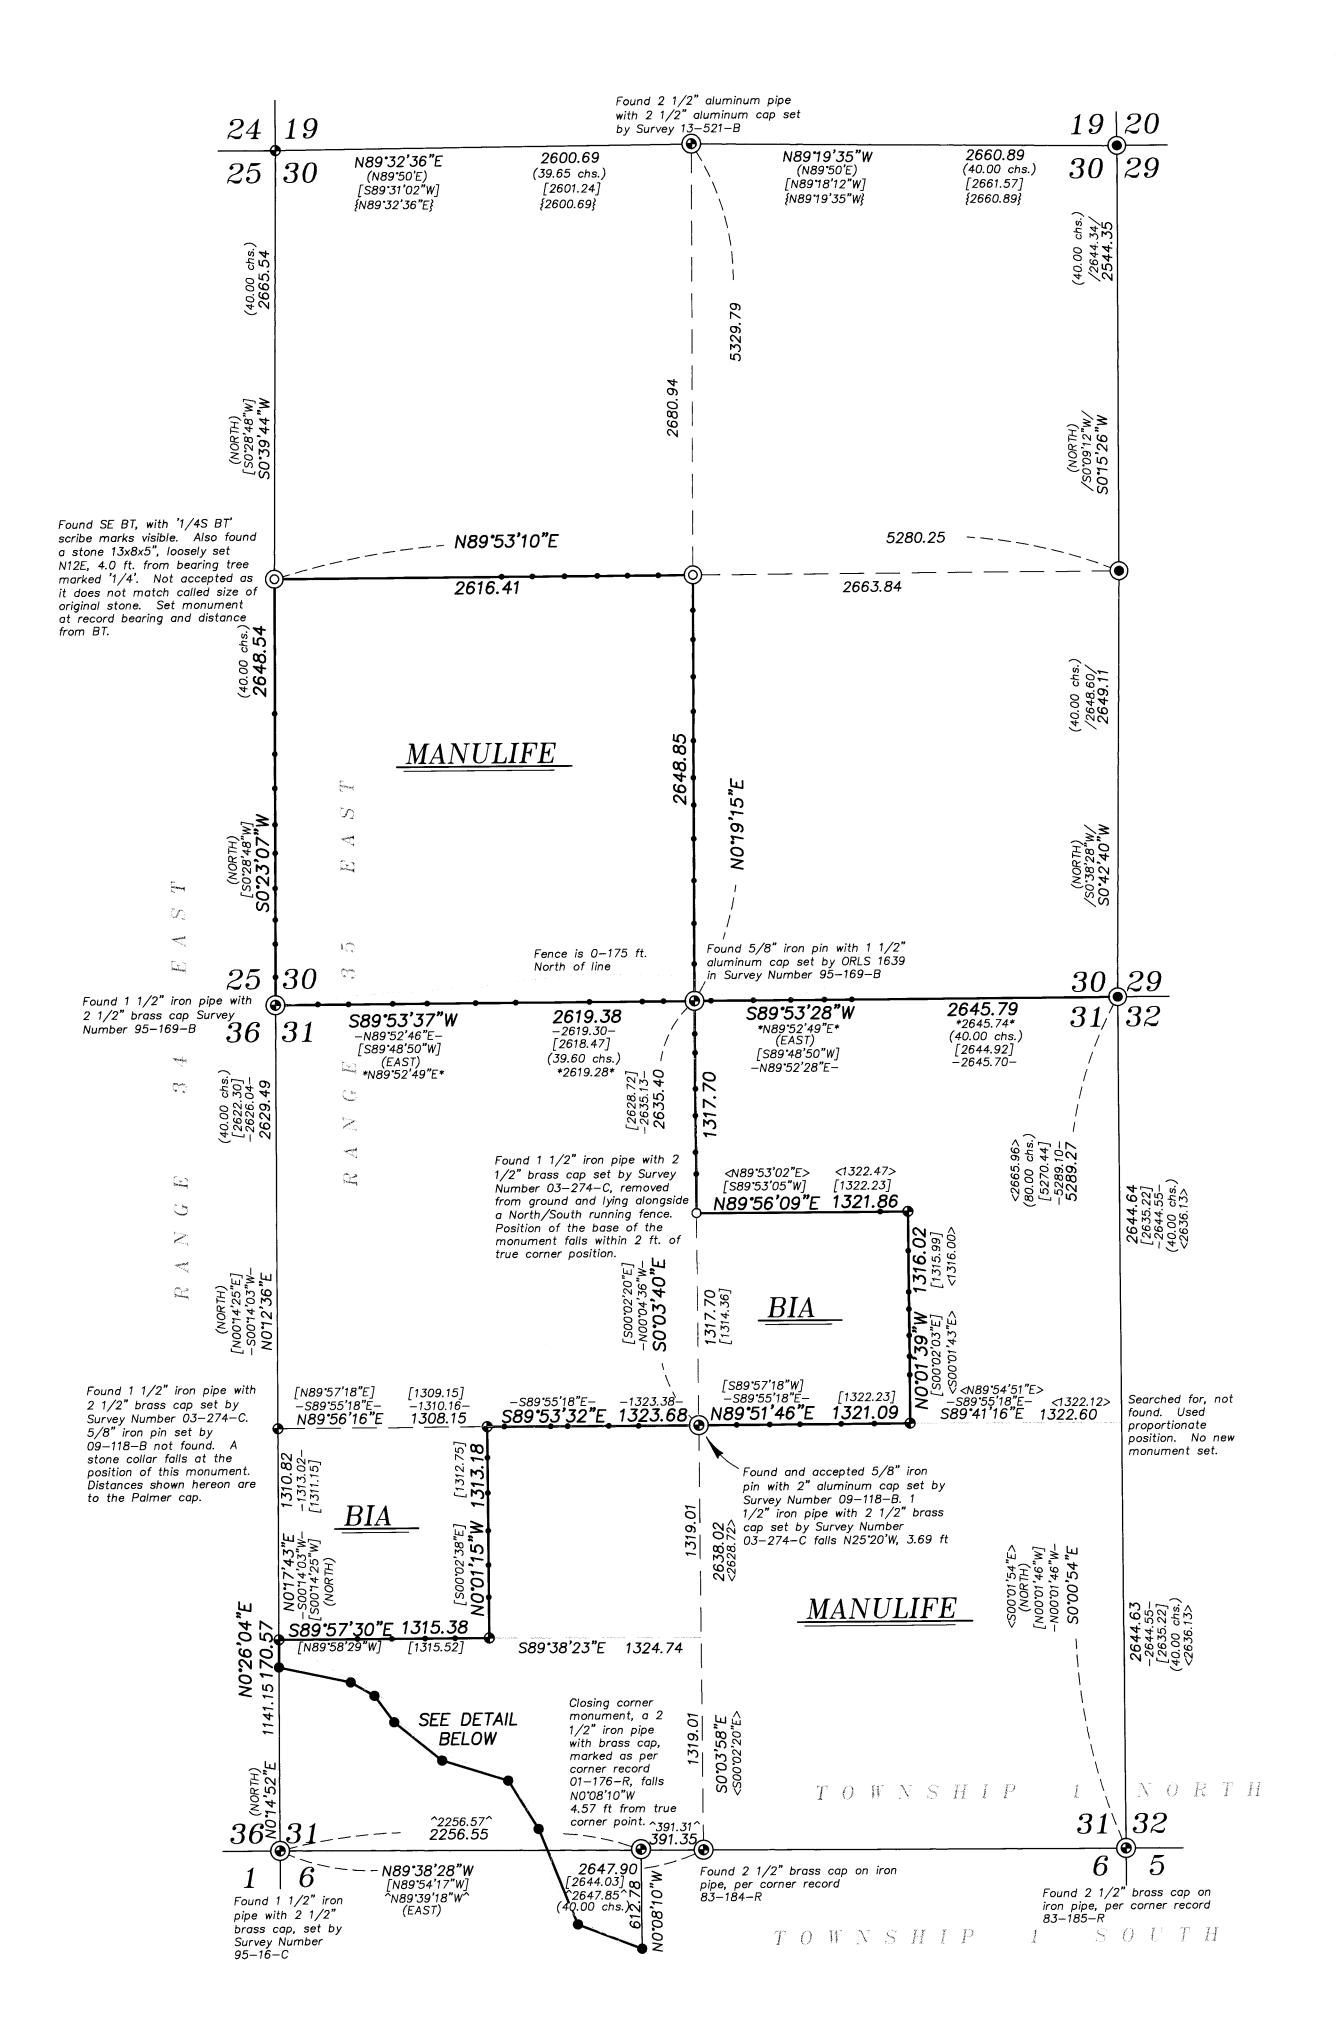
BASIS OF BEARING

True geodetic North at the Southwest corner of Section 19, Township 1 North, Range 35 East of the Willamette Meridian, as determined by GPS observation

SCALE: 1"=600'

I begin by subdividing the section based on a retracement of Survey 09-118-B.

The Center-North 1/16th corner was found removed and lying horizontally alongside a recently constructed fence. I reset this corner as per BLM Manual of Instructions.

This position falls in line with said fenceline.
I subdivide Section 30 as per BLM Manual of Instructions 2009. Fencelines are off as shown. I find no other unusual conditions with this survey.
