## OREGON CORNER RESTORATION FORM

### CORNER DESIGNATION: T1S, R30-1/2E, R-21

SOUTHWEST CORNER OF SECTION 24, TOWNSHIP 1 SOUTH, RANGE 30-1/2 EAST, W.M., UMATILLA COUNTY, OREGON.

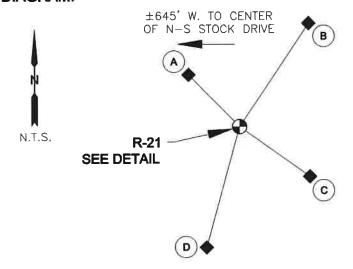
# **DIAGRAM:**

AT FOUND STONE LOCATION, SET 2-1/2 INCH BRASS CAP ON 1" (I.D.) X 30" GALVANIZED IRON PIPE, 7" ABOVE GRADE, MARKED AS SHOWN IN DETAIL BELOW. REINFORCED EXPOSED PIPE WITH STONE MOUND AND SOIL TO CAP. SET 4 REFERENCE MONUMENTS AS DESCRIBED AND DETAILED BELOW. BURRIED CORNER STONE IN MOUND ALONG SIDE THE PIPE. BEARINGS WERE TAKEN WITH HANDHELD COMPASS; DISTANCES WERE MEASURED WITH FIBERGLASS TAPE MEASURE.

- A SET 5/8" X 30" STEEL REBAR MARKED "UCPWD LS89374" BEARING OBJECT SIGN ATTACHED TO REBAR. CORNER BEARS S 42' F. 61'.
- B SET 5/8" X 30" STEEL REBAR MARKED "UCPWD LS89374" BEARING OBJECT SIGN ATTACHED TO REBAR. CORNER BEARS S 36" W, 104'.
- SET 5/8" X 30" STEEL REBAR MARKED "UCPWD LS89374" BEARING OBJECT SIGN ATTACHED TO REBAR. CORNER BEARS N 54" W, 72'.
- D SET 5/8" X 30" STEEL REBAR MARKED "UCPWD LS89374" BEARING OBJECT SIGN ATTACHED TO REBAR. CORNER BEARS N 16" E, 104'.
