## CERTIFIED RECORD OF LAND CORNER MONUMENTATION

SUBMITTED BY CITY ENGINEERING DEPARTMENT CITY ENGINEER Age

PENDLETON, OREGON

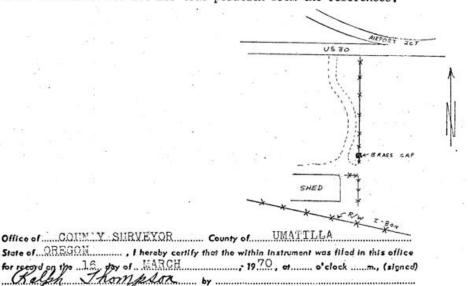
A 5/8" Iron rod was found in a North-South fence line.

The 5/8" Iron rod was referenced and removed. A Brass cap mounted on an iron pipe was then set in concrete for the new monument.

The brass cap is stamped "umatilla county surveyor 1/4 /8"

The cross in the center was set for true position from the references.
