OREGON CORNER RESTORATION FORM

Section 2 Township 3N Range 28E
 County Umatilla Date: 06-14-02

Corner Designation: 3N28A21

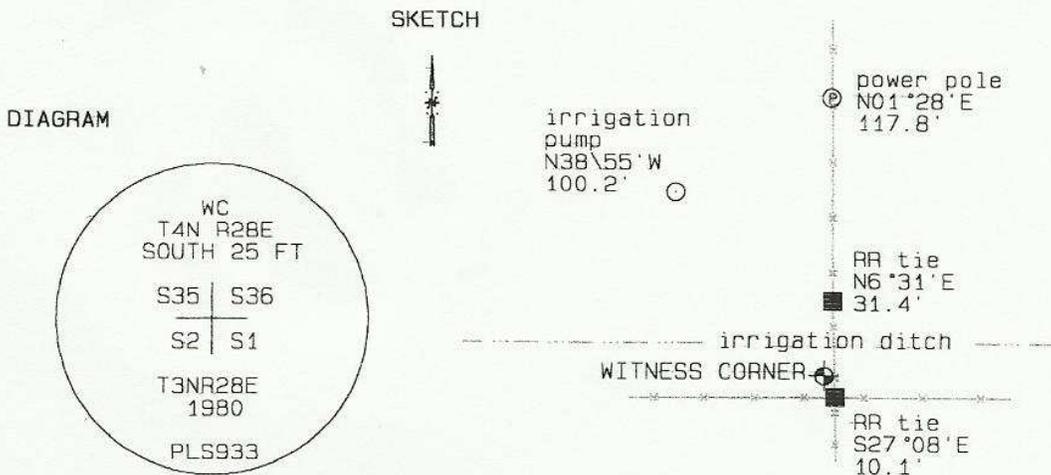
Previous Renewals / Surveys, etc.
 Survey S-156-C set witness corners at this point.

Monument and Accessories Found: (condition and source)
 Found one brass capped witness corner as shown below.
 Northern witness corner not found.
