OREGON CORNER RESTORATION FORM

SECTION: 3

TOWNSHIP: 4N

RANGE: 29E

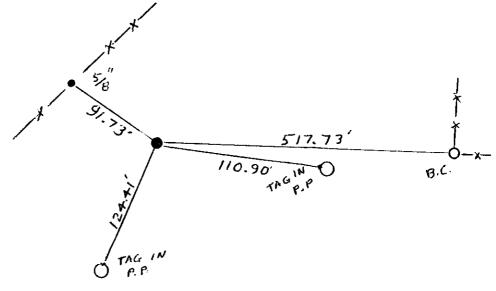
MONUMENT DETAIL

Found 2 3/8" brass cap 20" below the surface.

T5N R29E 33 4 | 3 **T4N R29E** 1990 LS 951

NAD 83/91

OREGON STATE PLANE INTERNATIONAL FEET

803955.68

8537284.76
