# OREGON CORNER RESTORATION FORM

SECTION: 10 TOWNSHIP: 4N RANGE: 29E E-17

COUNTY: UMATILLA DATE: 9/2013

NE COR. UNRECORDED

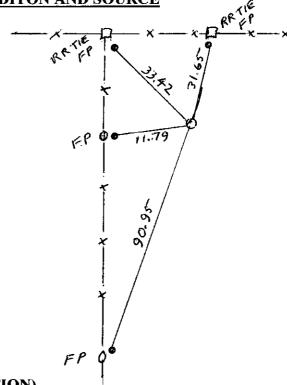
#### **MONUMENT DETAIL**

T4N R29E <u>\$3 | \$2</u> \$10 | \$11 2013 LS 951

NAD 83/91 OREGON STATE PLANE INTERNATIONAL FEET 798747.16 8542639.53

At the computed location of this corner on my Partition Plat 2011-07 (which was based on the computed location on B. Primm's 2006 survey #06-475-B) I set a 1"x15" iron pipe with a 2 ½" brass cap stamped as above 24" below the surface of a cultivated field and poured concrete around.
