## OREGON CORNER RESTORATION FORM

SECTION 14,23 TOWNSHIP 4 NORTH RANGE 29

COUNTY : UMATILLA DATE MAY/20

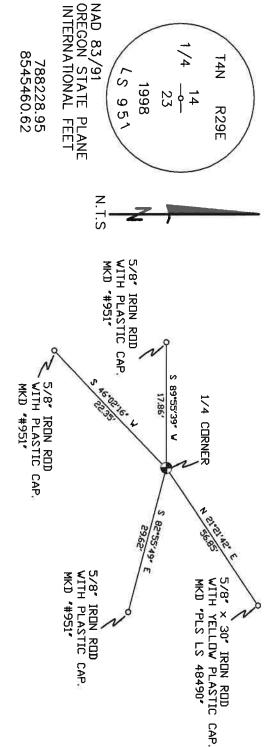
MONUMENT DETAIL

ORIGINALLY SURVEYED IN 1861 BY DAVENPORT UNDER CONTRACT #101. IN A MOUND OF EARTH AND A CHARRED STAKE. IN 1998 EDWARDS SET A 2" ALUMINUM CAP STAMPED AS BELOW. Æ SET  $\triangleright$ POST

5/8" IRON ROD WITH A PLASTIC CAP MKD 5/8" IRON ROD WITH A PLASTIC CAP MKD 5/8" IRON ROD WITH A PLASTIC CAP MKD 2" ALUMINUM CAP STAMPED AS BELOW. "951" LIES "951" LIES "951" LIES S 46.02,16" S 89.55,39" S 82.55,49"  $\mathbb{M} \lesssim \mathbb{R}$ 22.35 17.86 29.62 FEET FEET FEET

A 5/8" × 30" IRON ROD WITH A YELLOW PLASTIC CAP MKD "PLS S 48490" LIES Z 21.21,42" Ĺ 56.85 FEET.
