OREGON CORNER RESTORATION FORM

SECTION 19 TOWNSHIP 5N RANGE 28

COUNTY: UMATILLA

SW Corner

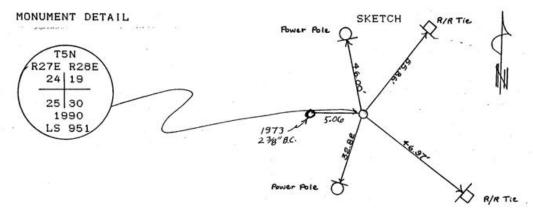
MONUMENTS & ACCESSORIES FOUND: Condition and Source Found a 1"x30" Iron pipe with a 2 3/8" Brass Cap, set by Krumbein in 1973 (See County Survey #1-16-C). This cap is 0.70 ft. below surface of a gravel rd. and N 89° 49' 24" W 5.06 ft. from my single proportion location.

MONUMENT SET (PROCEDURES AND DESCRIPTION) Set by single proportion a 1"x30" Iron pipe with a 2 3/8" Brass Cap, stamped as shown, 0.35 ft. below the surface of a gravel rd. SEE AREA ONE 1989 UMATILLA CO. SUR.
