OREGON CORNER RESTORATION FORM

Section: 25,26,35,36
Township: 6 North
Range: 35 East of the Willamette Meridian
County: Umatilla
Date: June 28, 2002

This corner is common to sections: 25,26,35,36

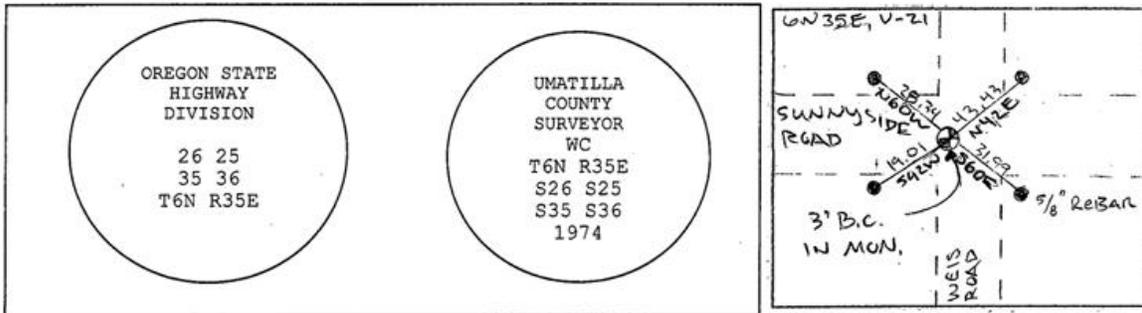
Monument Detail:

At the southwest corner of section 25, T6N R35E, we found a 3" brass cap in 5" diameter iron monument case 2 1/2" below the surface pavement. From which a 2 1/2" brass cap stamped as shown bears N42°E ~ 43.43 feet.

New Accessories: WE SET:

Attached a Umatilla County Bearing object sign to south face of telephone junction box at the bottom NE or the witness corner. A 5/8 rebar with yellow plastic cap stamped 'Tomkins Surveying' which bears S 60°E ~ 31.99 feet from the corner. Attached a Umatilla County Bearing object sign to the northwest face of power pole. A 5/8 rebar with yellow plastic cap stamped 'Tomkins Surveying' which bears S 42°W ~ 19.01 feet from the corner. No Umatilla County Bearing object sign or t-post set. A 5/8 rebar with yellow plastic cap stamped 'Tomkins Surveying' which bears N 60°W ~ 28.34 feet from the corner. No Umatilla County Bearing object sign or t-post set.
